## IMPROVEMENT LOCATION REPORT

that on October 28, 2014, I made an inspection of the premises situated at Off of U.S. Highway 64 in Taos Canyon, Taos County, NM, briefly described as (within Sections 19 & 30, Township 25 North, Range 14 East, NMPM; also pt. Tracts 18 & 30 of the 1941 TCRS and Tracts "A" "B" "C" "D" of referenced plat) also Tract "A" referenced plat).

WALTER WOODROW GILLAND, JR., TRUSTEE OF THE JOSEPH ANTHONY D'ALESSANDRO 2013 TRUST

TRACTS "A" Thru "D"

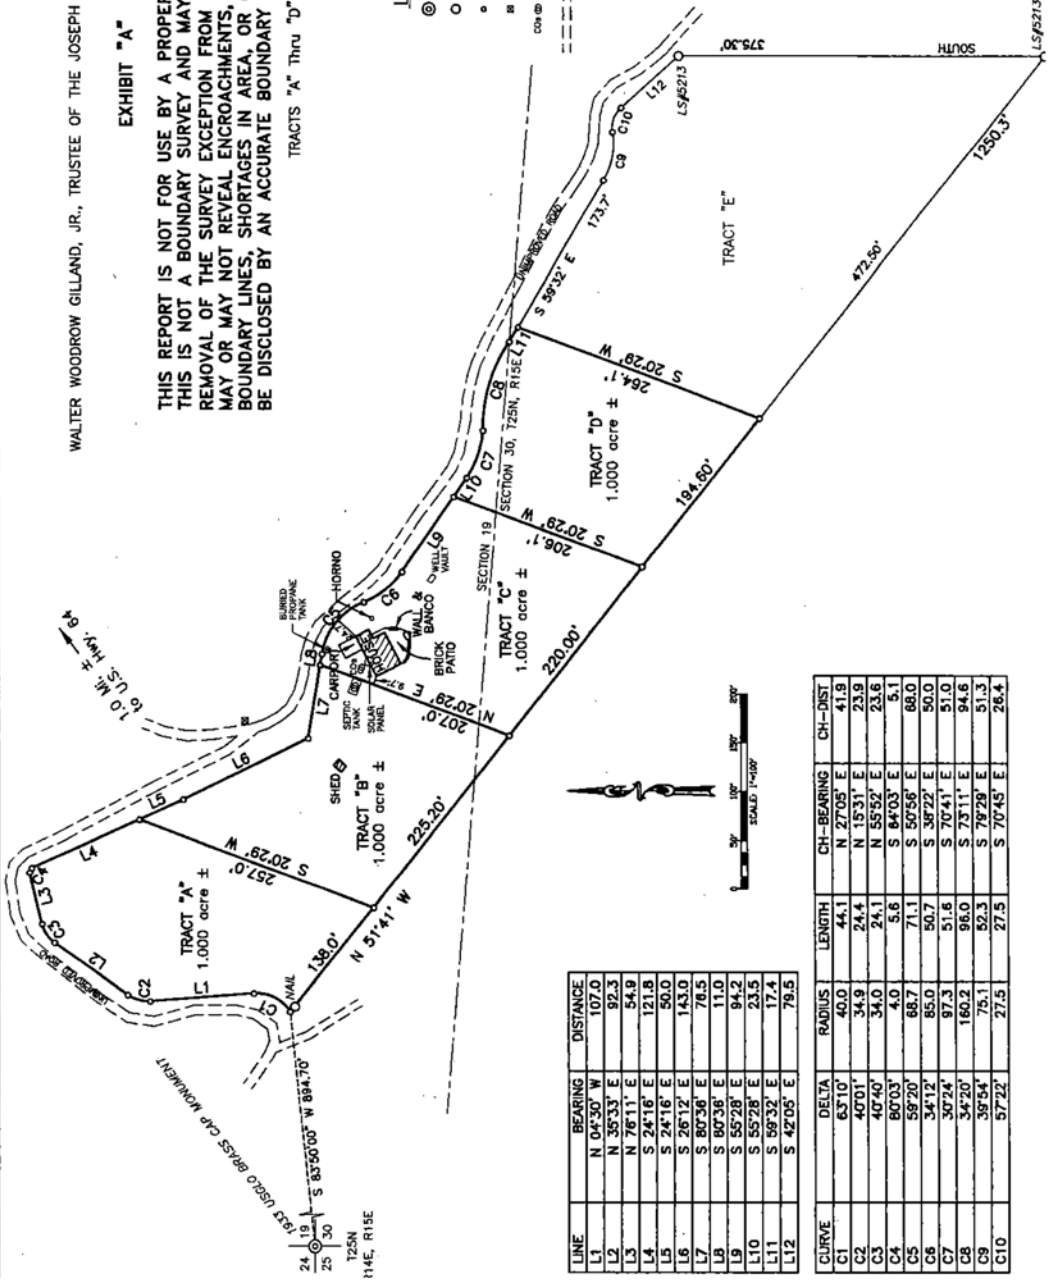
EXHIBIT "A"

**Shown on Exhibit "A"**

Yes: **Shown on Exhibit "A"**
