1/4 of Section 28, Township 25 North, Range 14 East, NMPM:
 In Taos Canyon, Taos County, New Mexico.

Sheet 2 of 2

PROPERTY SURVEY	
Current owner: Jerri L. Ward	
Section: 28, T 25 N, R 14 E, NMPM	
Survey plat prepared for:	
Ward to Neblina

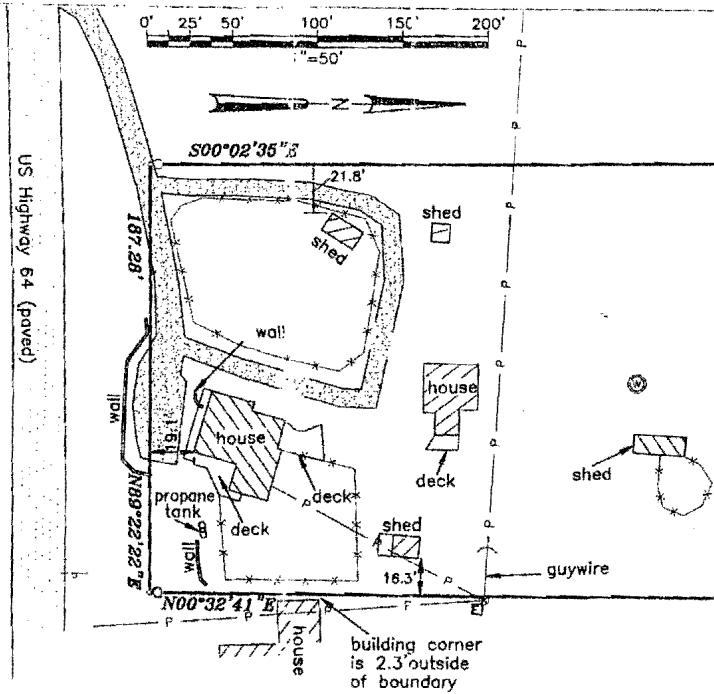
ENLARGEMENT OF SOUTHERN PORTION

(S00°06'E, 1513.80' P1, P3)
 (S00°30'14"E, 1524.94' P2)

6.828 acres±
 Part of General Homestead
 Patent No. 3914

(N00°22'E, 1506.70' P1)
